Manhole Inspection Summary

Manhole # S31M1_003MH

Location Address: **523 Cherry Hill Road**

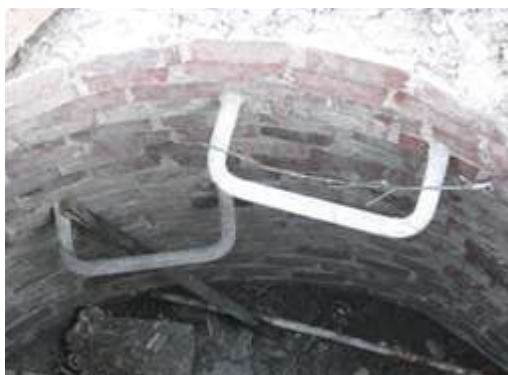
Steps Count: **2** Missing: **0** ☐ Corroded

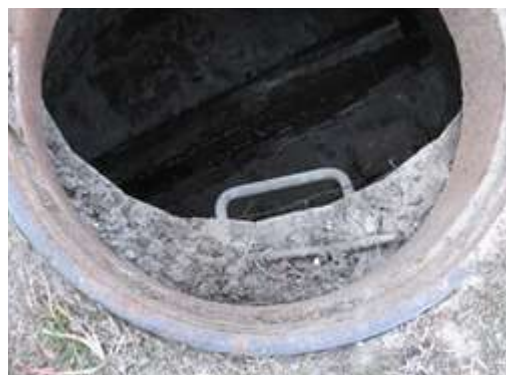
Defect 2

Frame Offset: **6** (in.) Condition: ☒ Sound ☐ Cracked ☐ Leaks

Frame offset

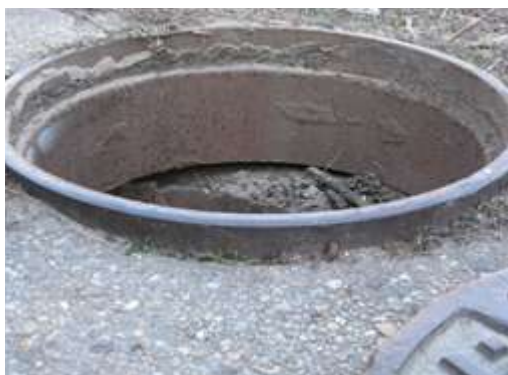
Defect 1

Cover Shape: **Circular** Diameter: **24** (in.) Length: (in.) Dist A/B Grade: **1.5** (in.)

Above grade

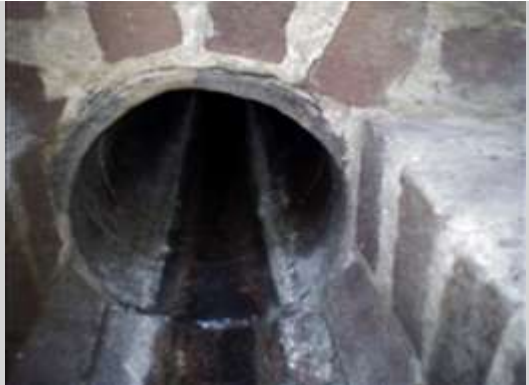
12 O'Clock Outflow

8 in. Circular Gravity Sewer
Pipe Out @ 12 O'Clock

Infiltration: **None** Pipe Seal Cond: **Sound**

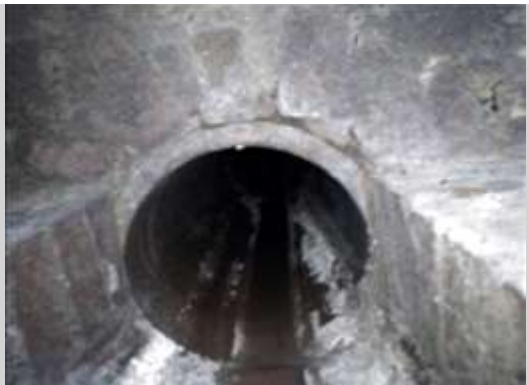
6 O'Clock Inflow

8 in. Circular Service Sewer
Pipe In @ 6 O'Clock

Infiltration: **None** Pipe Seal Cond: **Sound**
